PHASE II SITE CHARACTERIZATION REPORT FOR THE SILVER CREEK DRAINAGE PROJECT

Lewis & Clark County, Montana

DEQ Contract No. 401026

January 2003

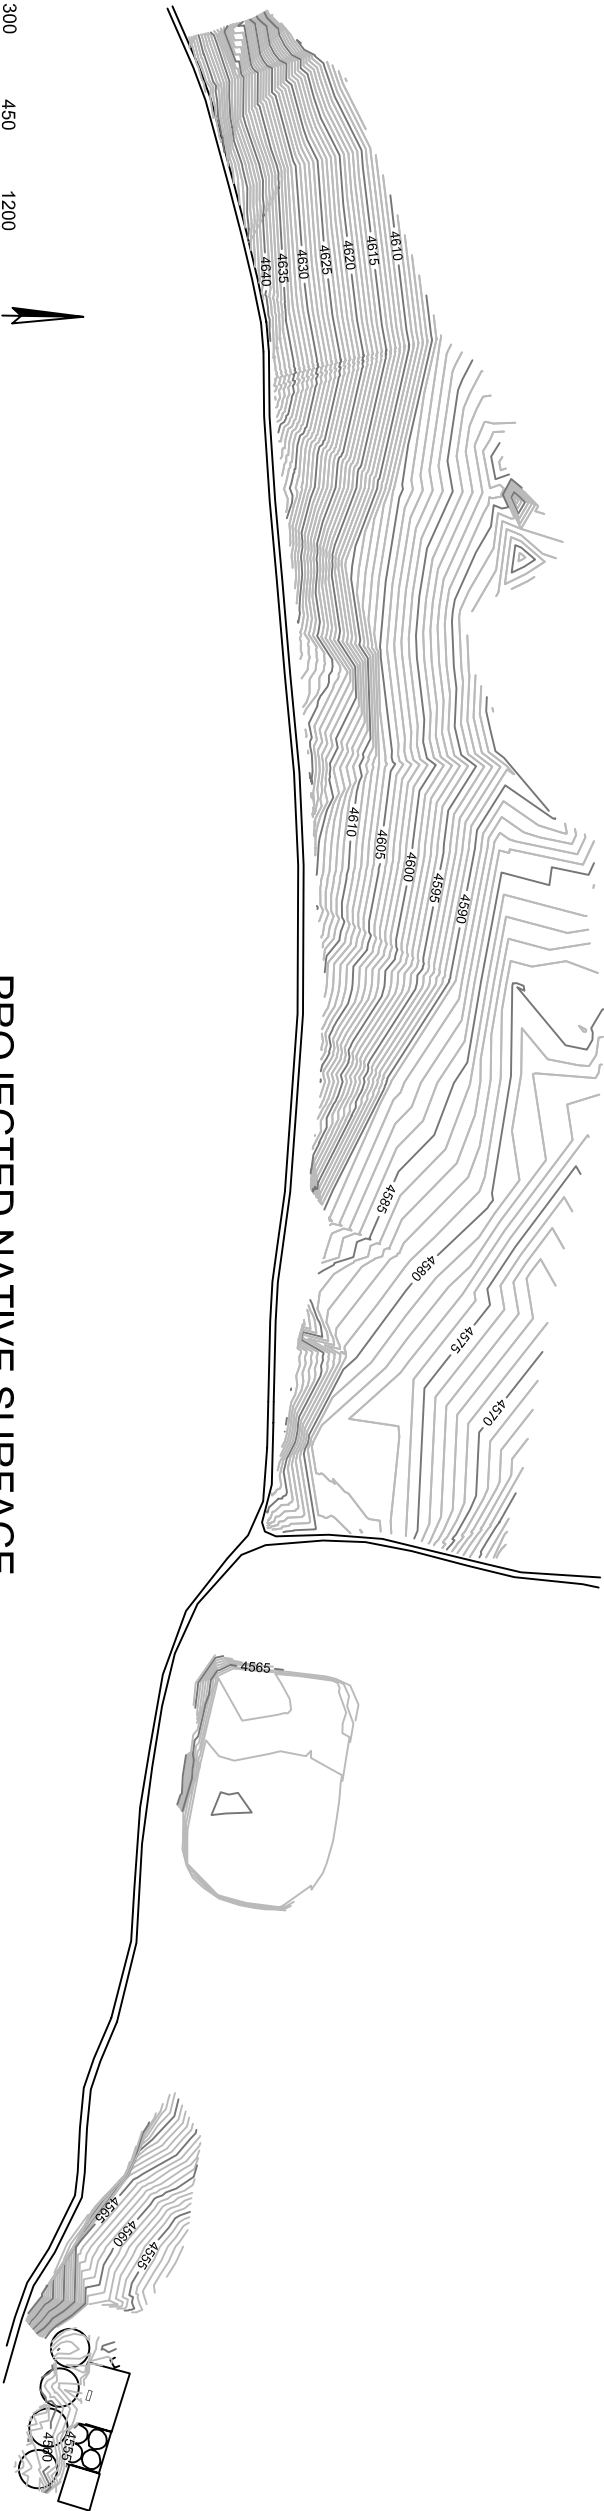
The volume of the main Goldsil tailings was calculated using Eagle Point surface models. The existing tailings surface model was compiled from the topographic survey. The native surface (Figure 6-8) was triangulated from native surface elevations encountered in the test pits and drill holes. A total of 35 test pits were excavated and nine holes were drilled into the main Goldsil tailings (Figures 6-4 and 6-5). The estimated volume of the main Goldsil tailings is 458,430 cubic yards (Table 6-2). The tailings plan area is 18.68 acres and the average tailings depth is 15.21 feet. The maximum tailings thickness measured in the drill holes was 42.65 feet.

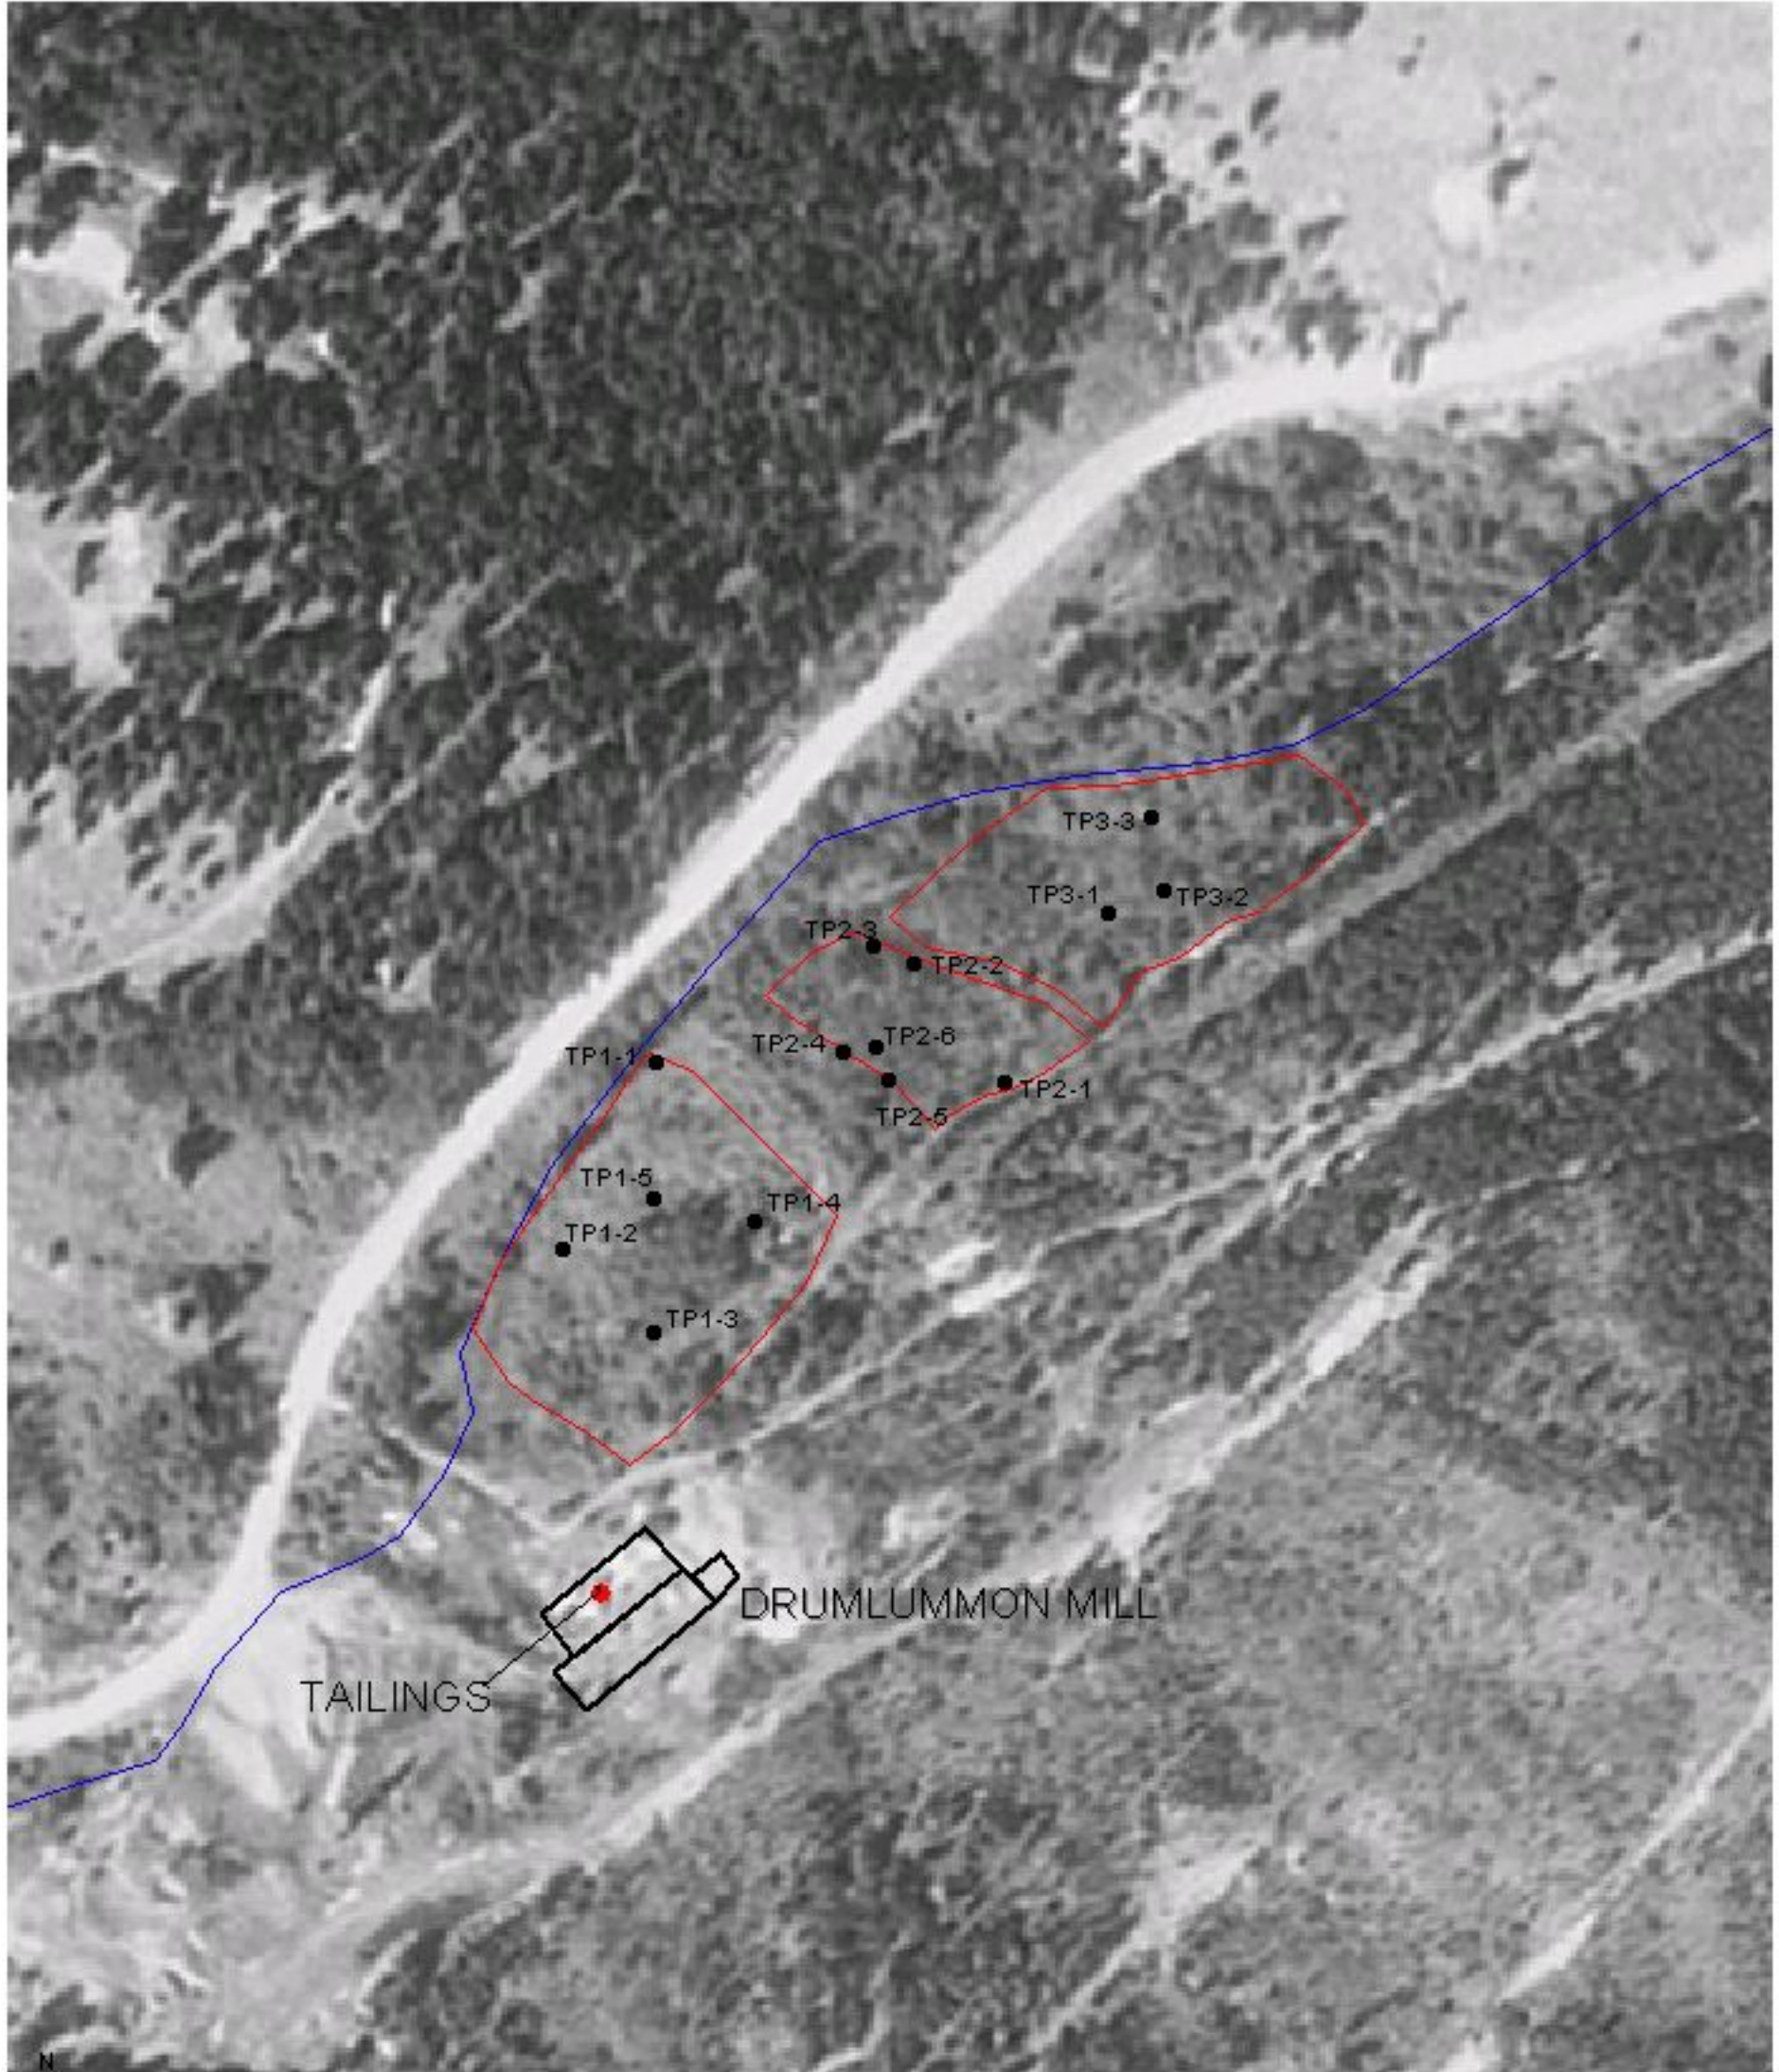
The Drumlummon millsite tailings piles (TP1, TP2 and TP3) are located in the SE¼ Section 36, Township 12 North and Range 6 West, Montana Principal Meridian (Figure 1-1). The aerial photograph presented in Figure 6-9 shows the location of the tailings piles and test pits used to evaluate the Drumlummon millsite tailings. The tailings piles are located within 900 feet downstream along the Silver Creek drainage from the Drumlummon mill foundation. A berm diverts Silver Creek to the north of the three tailings piles along Marysville Road. Tailings pile TP1, which is the farthest upstream, is formed by a dam across the drainage bottom. The dam has a 10-inch steel pipe through it to provide overflow drainage. The dam is approximately 15 feet high on the downstream side, and there is approximately 8 feet of freeboard on the upstream side. The tailings in the pond are well vegetated with grass and willows.

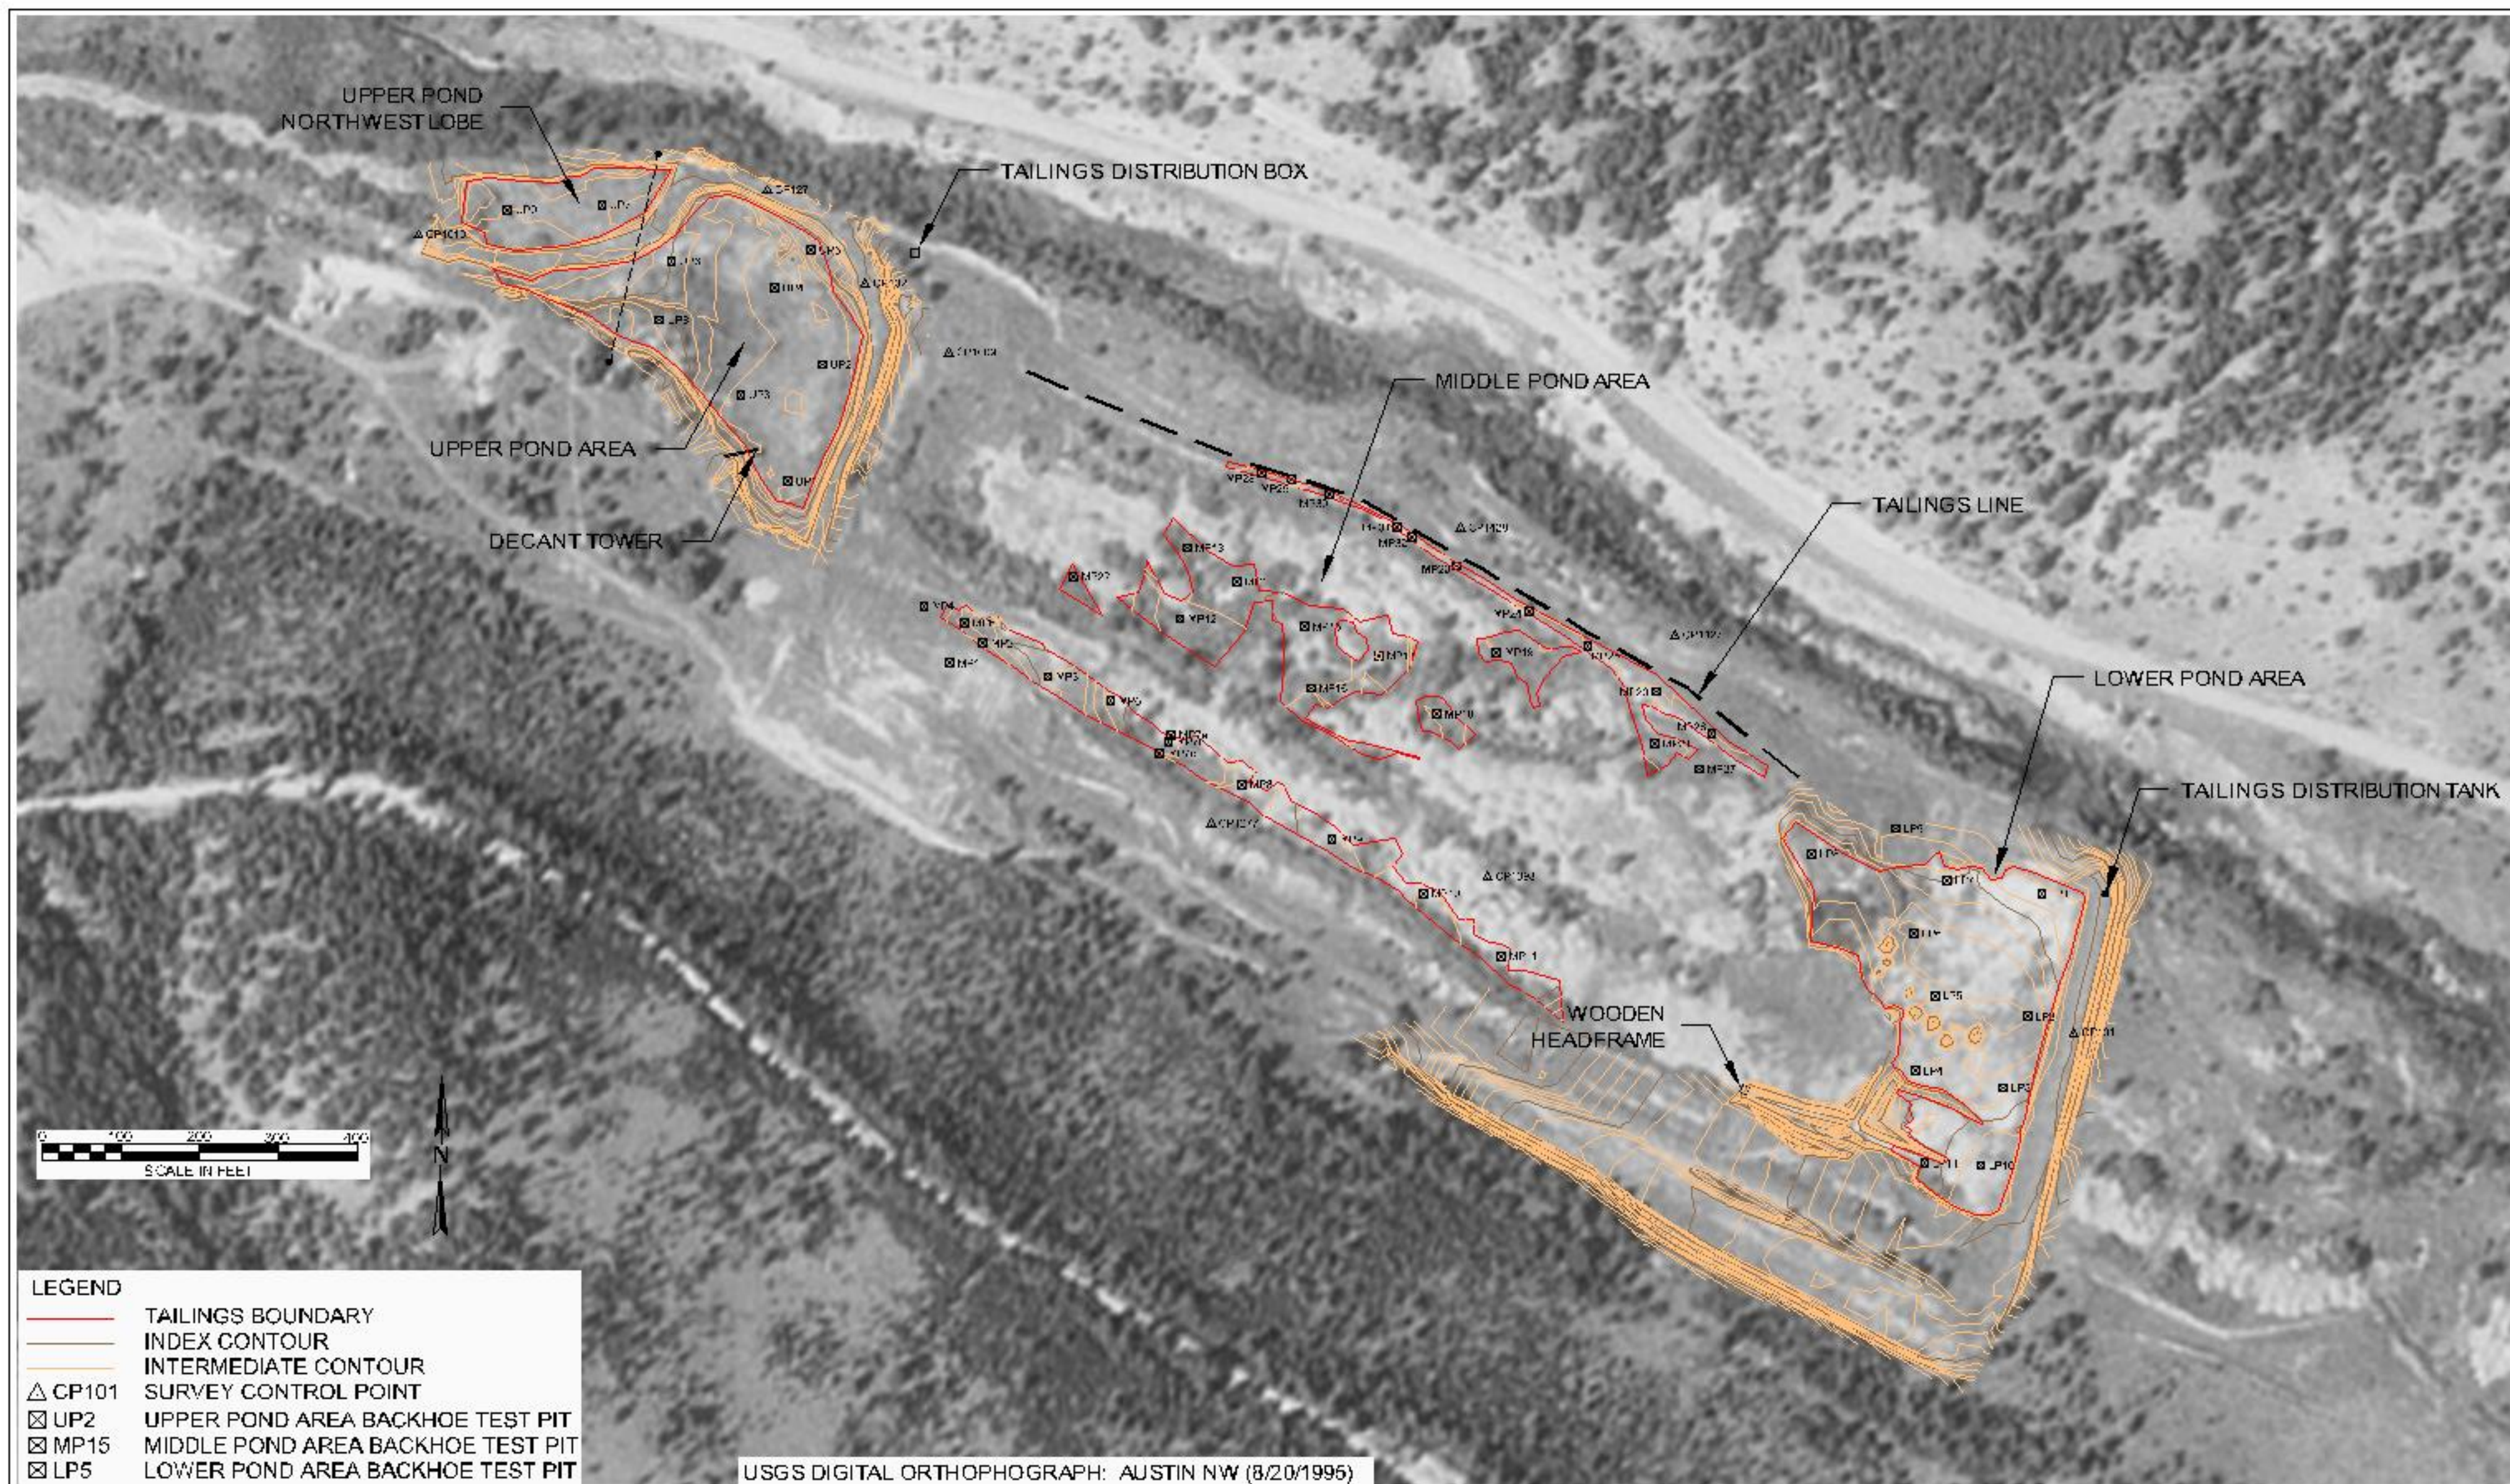
Olympus Technical Services, Inc.	AERIAL PHOTOGRAPH OF THE UPPER, MIDDLE AND LOWER POND AREAS	FIGURE 6-10
		APPROVED:	DATE: 8/20/02	JOB NO: A-221				
NO	REVISION DESCRIPTION	BY	DATE	SCALE: AS SHOWN	FILENAME: A-221T0608.dwg

Tailings in the Middle Pond Area were deposited in several areas between existing overburden and processed placer tailings piles (Figure 6-10). The Middle Pond and Lower Pond areas are separated by processed placer tailings piles that have been graded out. Tailings along the northern perimeter of the Middle Pond are associated with spillage from the tailings line between the Upper Pond and Lower Pond dams and are primarily contained in a ditch adjacent to the line. The tailings along the southern perimeter of the Middle Pond area were most likely spilled or discharged starting approximately 200 feet from the southern end of the Upper Pond dam. These tailings were deposited in a narrow, linear configuration between placer tailings piles.

Tailings in the central portion of the Middle Pond are found in pockets between placer tailings piles (Figure 6-10). The origin of deposition of these tailings was not visible in the field. Theories as to how these tailings were deposited include: 1) the tailings were deposited via another discharge line that has been removed, or 2) tailings could have overflowed from the north and south Middle Pond tailings areas in gaps between the hummocky placer piles. The first theory is more likely. A temporary pipe could have been run from the distribution box on the Upper Pond dam to the central portion of the Middle Pond area to discharge the tailings. This could also be how the tailings along the southern Middle Pond perimeter were discharged. The second theory is possible but less likely. It is conceivable that tailings slurry could pond up and flow through gaps in the placer tailings piles; however, direct evidence of this was not observed. A small rock berm was observed near the west end of the southern Middle Pond tailings area. It is possible that a gap in the placer tailings piles could have existed prior to placement of this berm; however, the Middle Pond tailings deposition areas appeared in the field to be completely separated. The Middle Pond tailings were identified in six subareas, consisting of three main and three smaller, isolated deposition zones. The tailings subareas are shown on Figure 6-13 and are designated as the following subareas: North, Middle, South, MP18, MP19, and MP22.

The principal discharge point for tailings into the Lower Pond Area appears to have been near the northeastern corner of the tailings dam. There is a steel distribution tank and associated PVC piping which were used to discharge tailings into the pond from the main tailings line. Field evidence of sections of metal-banded wooden pipe partially filled with tailings suggest that the main tailings line most likely ran along the northern boundary of the Lower Pond Area (Figure 6-10).

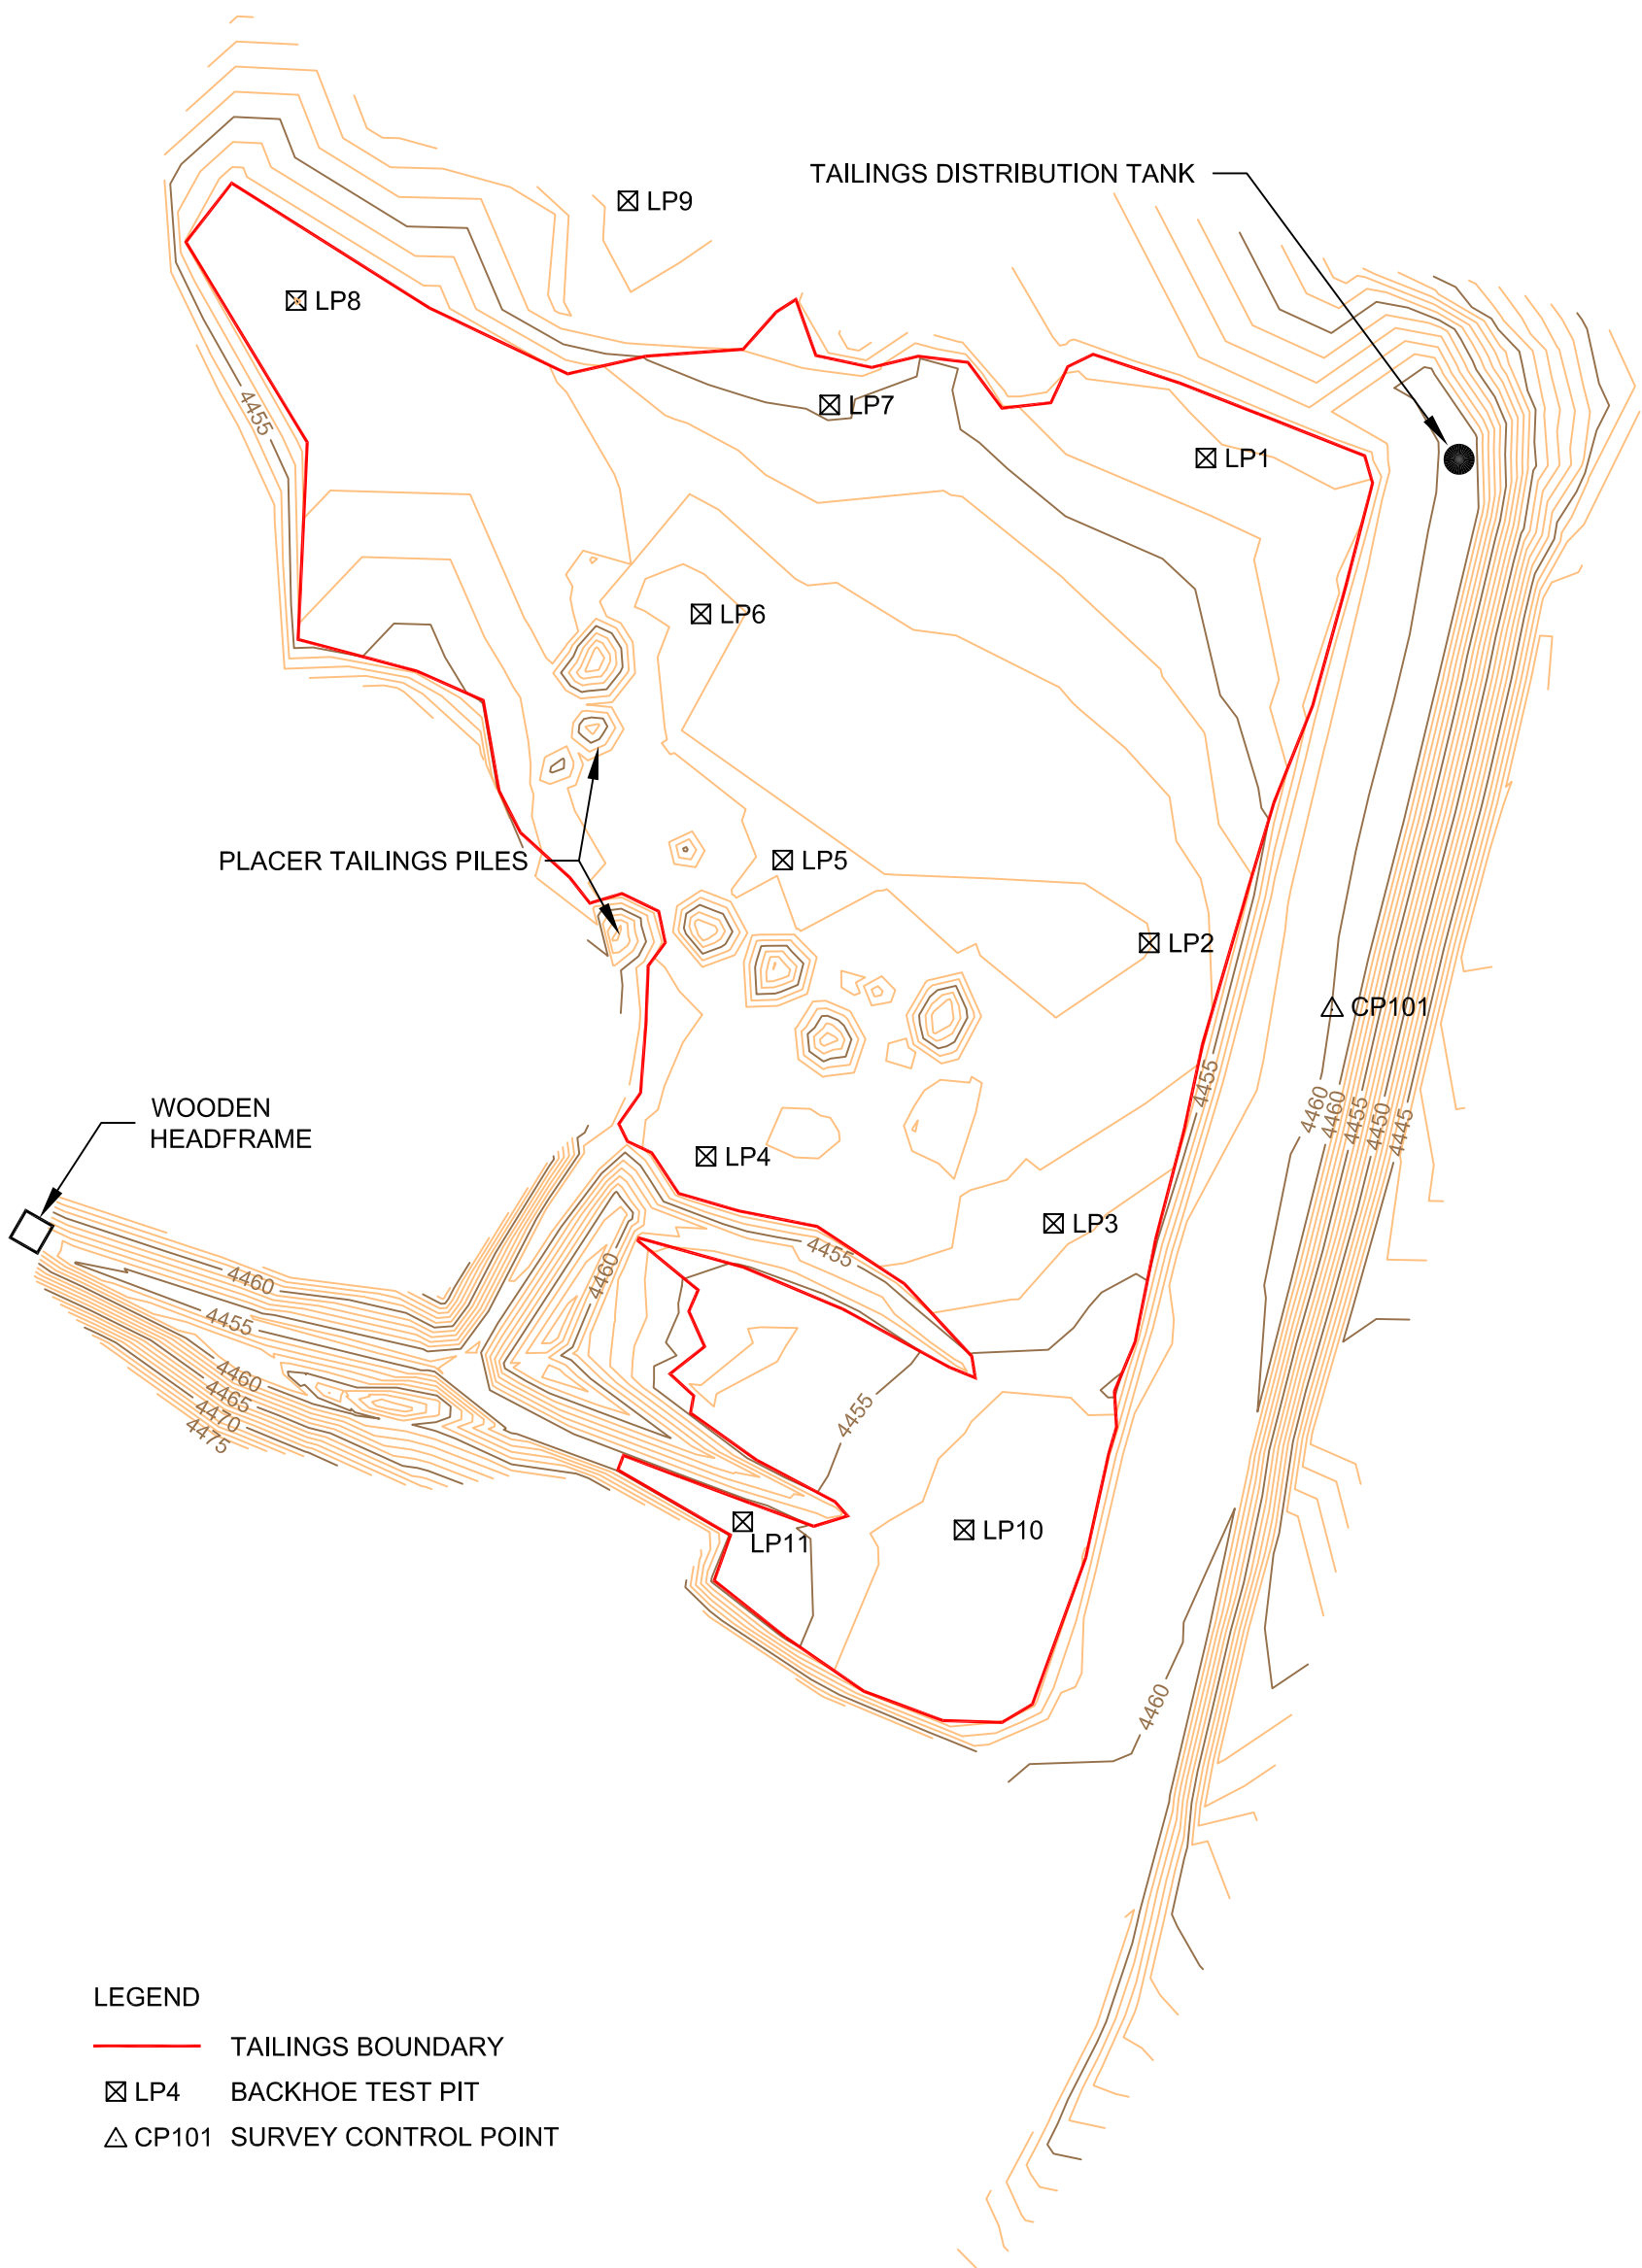
FIGURE
6-14

The location of the Lower Pond Area tailings is superimposed on an aerial photograph and is shown on Figure 6-10. A detailed survey of the Lower Pond tailings area was completed and the topographic map is shown on Figure 6-14. The tailings volume was estimated using the

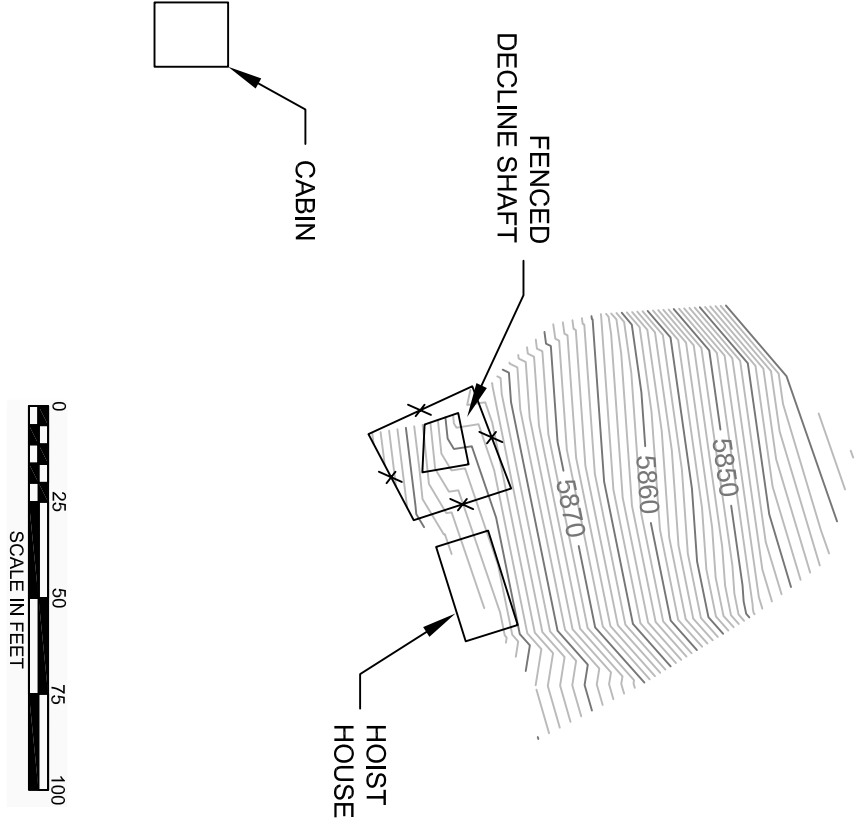
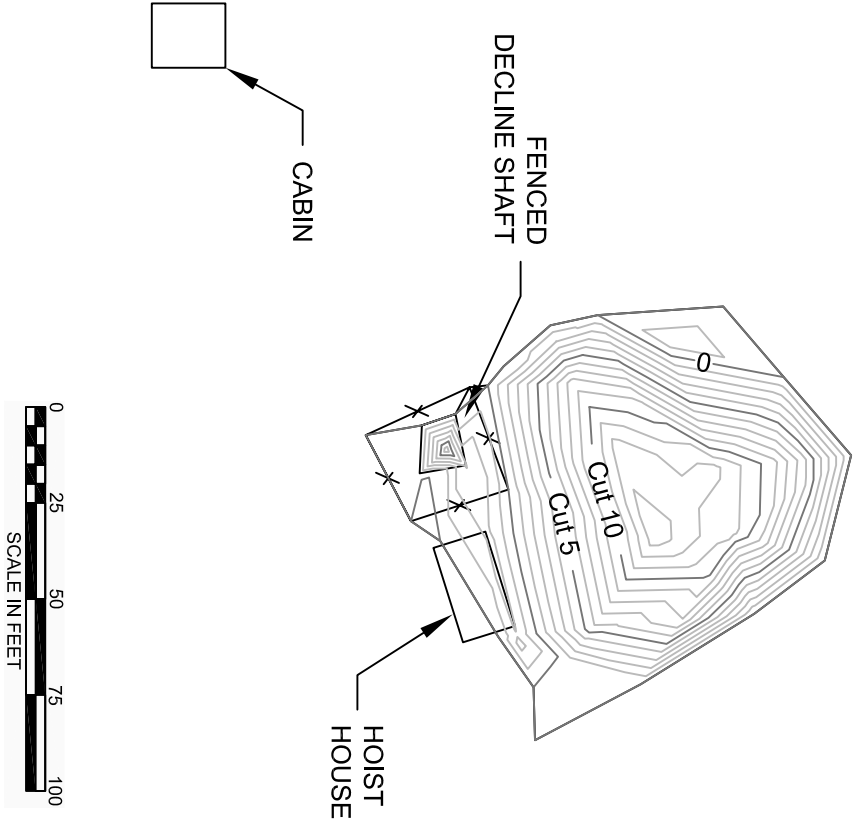
Waste rock pile WR1 is located near the east end of the Drumlummon mine area (Figure 6-16). A detailed topographic survey of WR1 was completed (Figure 6-17) and used to estimate the waste rock volume. The volume was calculated using Eagle Point surface models of the waste rock pile surface and the projected native surface below the pile. No test pits were excavated in the waste rock pile because of the coarseness of the material and the steep slope of the face. Therefore, the native surface below the pile was estimated by projecting from the hill slopes adjacent to the waste rock pile. The projected native surface and depth contours are shown on Figure 6-18. The estimated volume of WR1 is 1,460 cubic yards. The plan area of WR1 is 0.19 acres and the average waste rock depth is 4.71 feet.

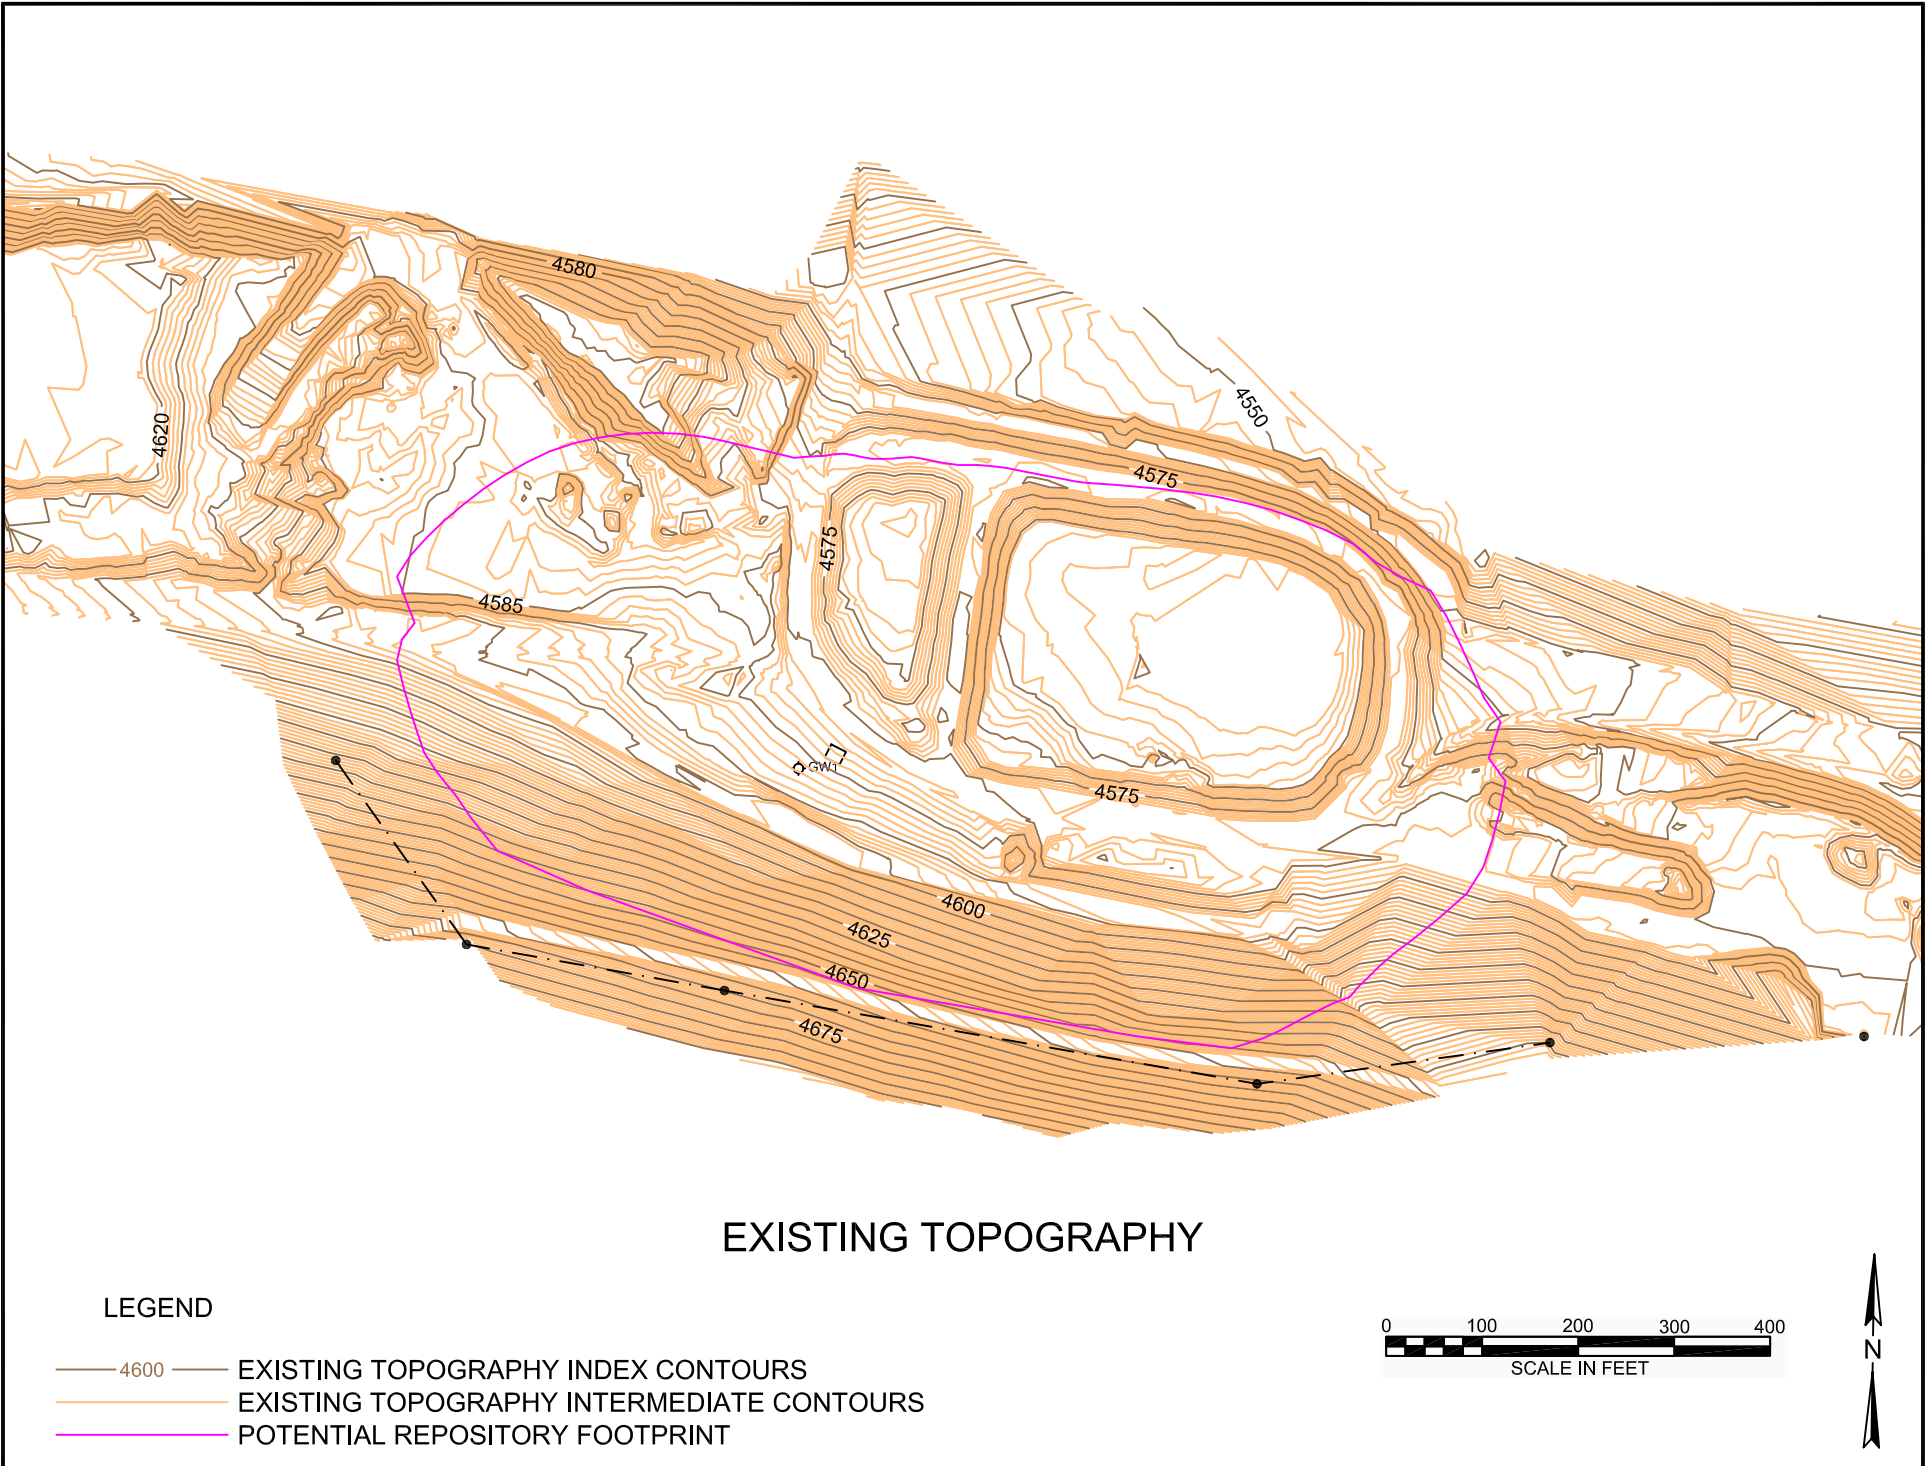
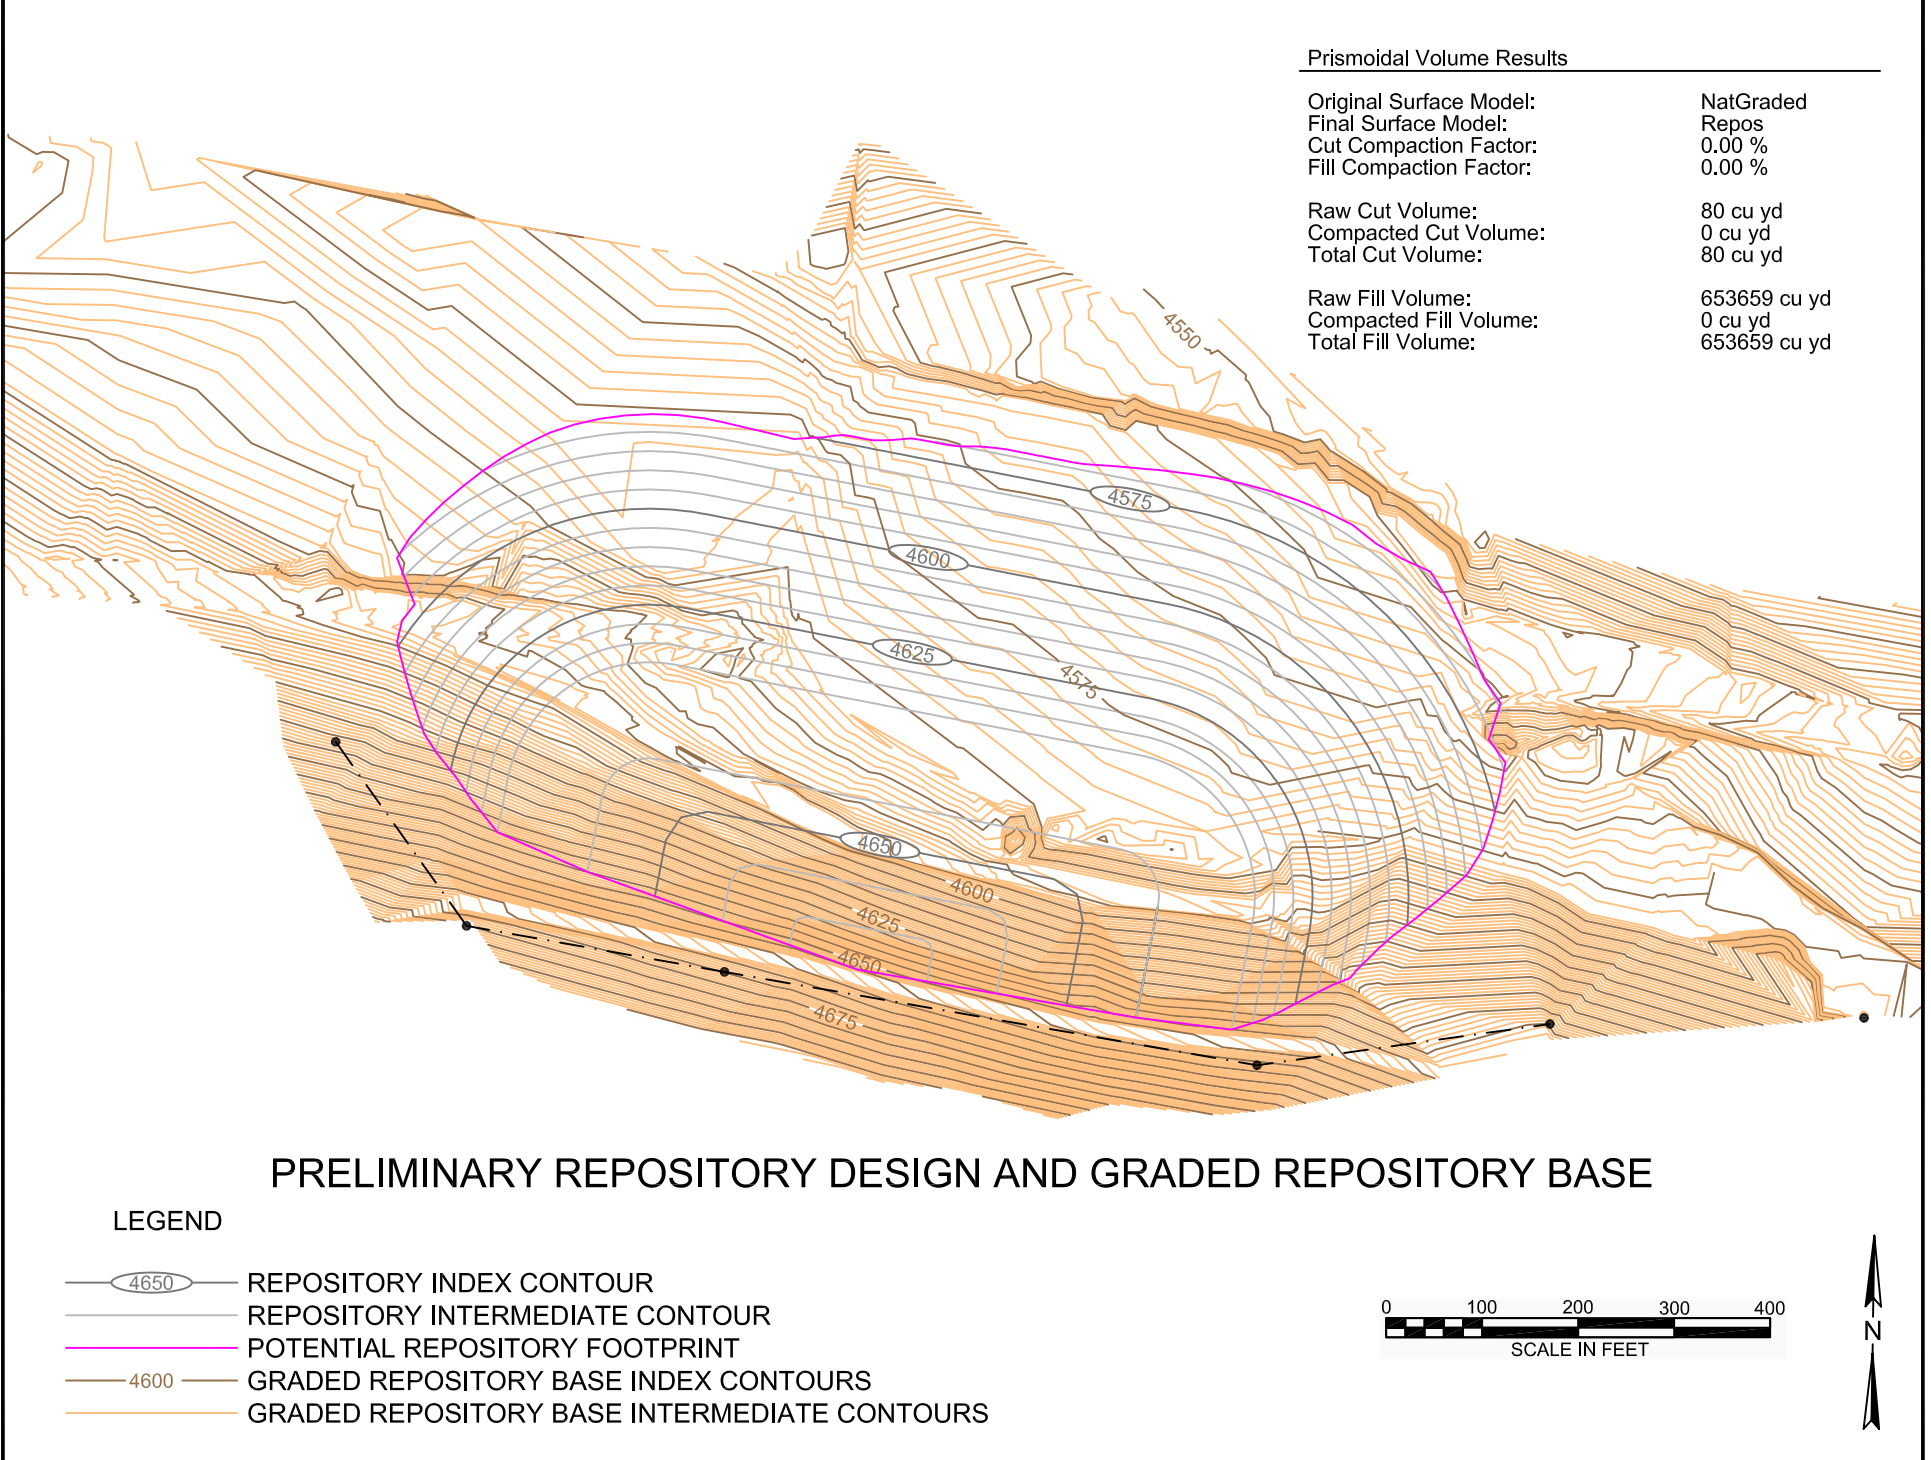
Based on the above criteria, a potential repository site was selected in the area of the lined tailings impoundment located within the Goldsill tailings area. The property is exclusively owned by the St. Louis Drumlummon Mines, Inc. Figure 11-1 shows the potential repository site area, existing topography and preliminary design. The design indicates that the repository would occupy 12.6 acres, have a maximum thickness of 70 feet, and could accommodate an estimated 654,000 cubic yards of waste. The subgrade would consist of colluvium and/or alluvium down to limestone bedrock. The depth to bedrock is estimated at 44 feet or less below the surface based on previous wells completed in bedrock by Lindsey Drilling in 1974 for Silver Creek Mining. Static water levels (December 4, 2002) in groundwater monitoring wells completed by Olympus in the potential repository area indicate that the water table in the alluvial aquifer would be 14.4 to 25.7 feet below the existing topographic surface. Groundwater flow is at a relatively steep gradient and flow direction essentially parallels Silver Creek in this area.
